OKLAHOMA GEOLOGICAL SURVEY
Charles J. Mankin, *Director*

CIRCULAR 88

**STABILITY PROBLEMS ASSOCIATED WITH
ABANDONED UNDERGROUND MINES
IN THE PICHER FIELD, NORTHEASTERN OKLAHOMA**

KENNETH V. LUZA

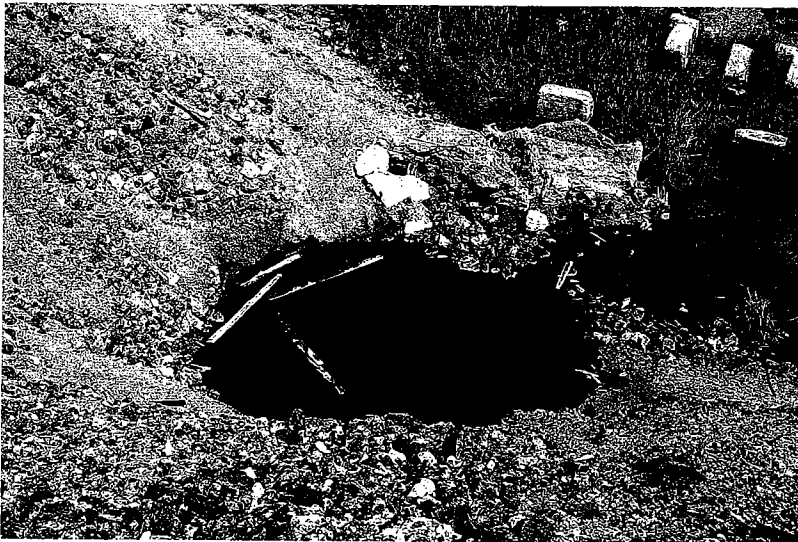
Title Page Illustration

A 20-ft-diameter circular collapse, Howe Mine, 29N-23E-17.

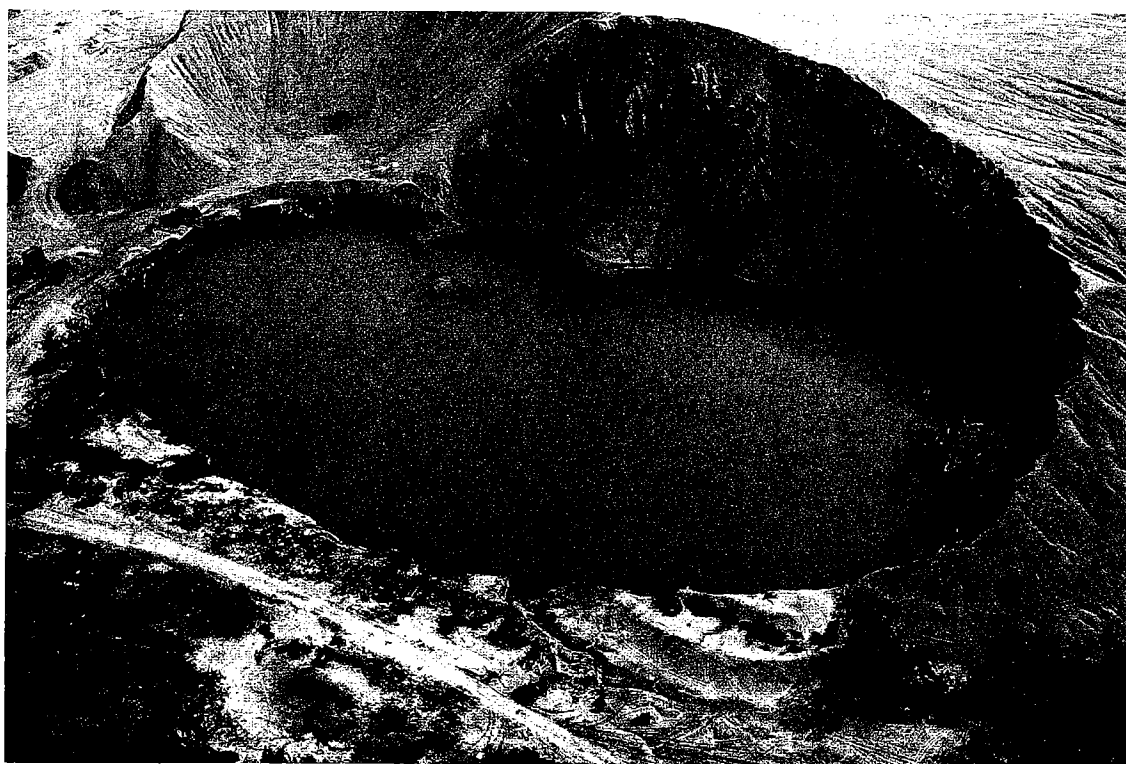
Most major collapses have occurred in rural areas. The largest concentration of shaft-related major collapses is found in a zone 0.5 mi wide by 1 mi long, extending southward from Hockerville (E½ secs. 14 and 23, T29N, R23E); 10 shafts are involved in eight separate collapses. Other areas that include several major shaft-related collapses are in sec. 19, T29N, R23E, west of Cardin, and near Commerce. The largest collapse feature in the district is associated with three shafts at the Domado Mine, sec. 29, T29N, R23E (Fig. 6). This collapse is 560 ft long and 400 ft wide, covering 4.04 acres, and is filled with water.

Figure 6. Aerial view of 4.04-acre collapse associated with three shafts at Domado Mine, 29N-23E-29 (1-3).

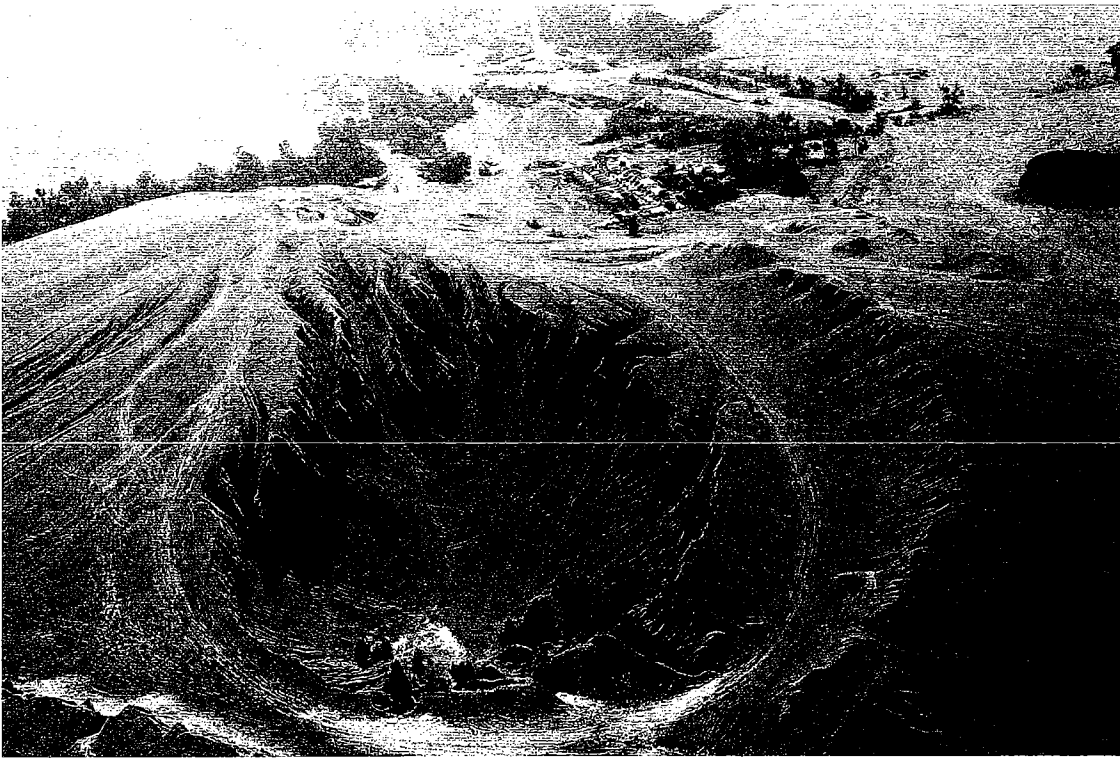
Of the 55 non-shaft-related collapses which were located, 30 fall within the major-collapse category. Approximately 20 surface acres have been disturbed as a result of non-shaft-related collapses. Sec. 1, T28N, R22E, west of Commerce, and sec. 19, T29N, R23E, west of Cardin, contain the largest concentration of non-shaft-related collapses. The largest non-shaft collapse is a 450- × 200-ft elliptical collapse that covers about 2.60 acres. This collapse occurs as a 20-ft-deep depres-

sion in a former tailings pile in sec. 30, T29N, R23E (Fig. 7).

Figure 7. Aerial view of largest non-shaft collapse (2.60 acres), Blue Goose No. 1 Mine, 29N-23E-30(1511).

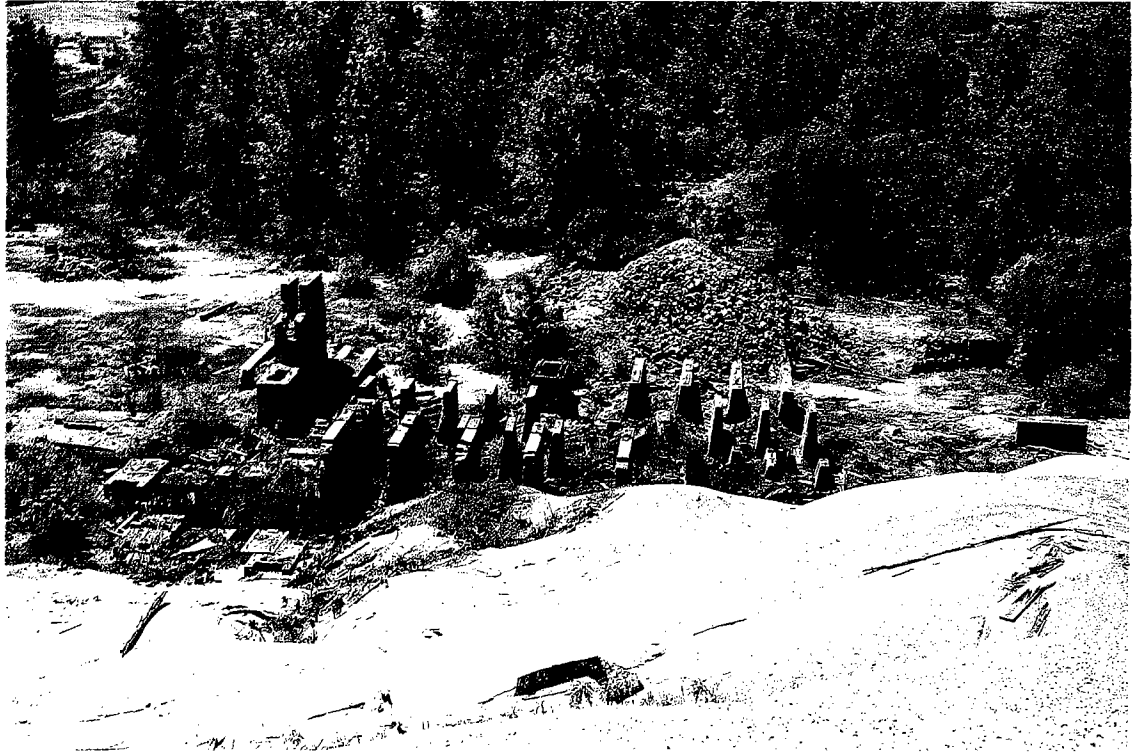
Figure 8. Foundation for former mill at St. Louis No. 4 Mine (29N-23E-24). Boulder pile is adjacent to mill, and chat pile is in foreground.

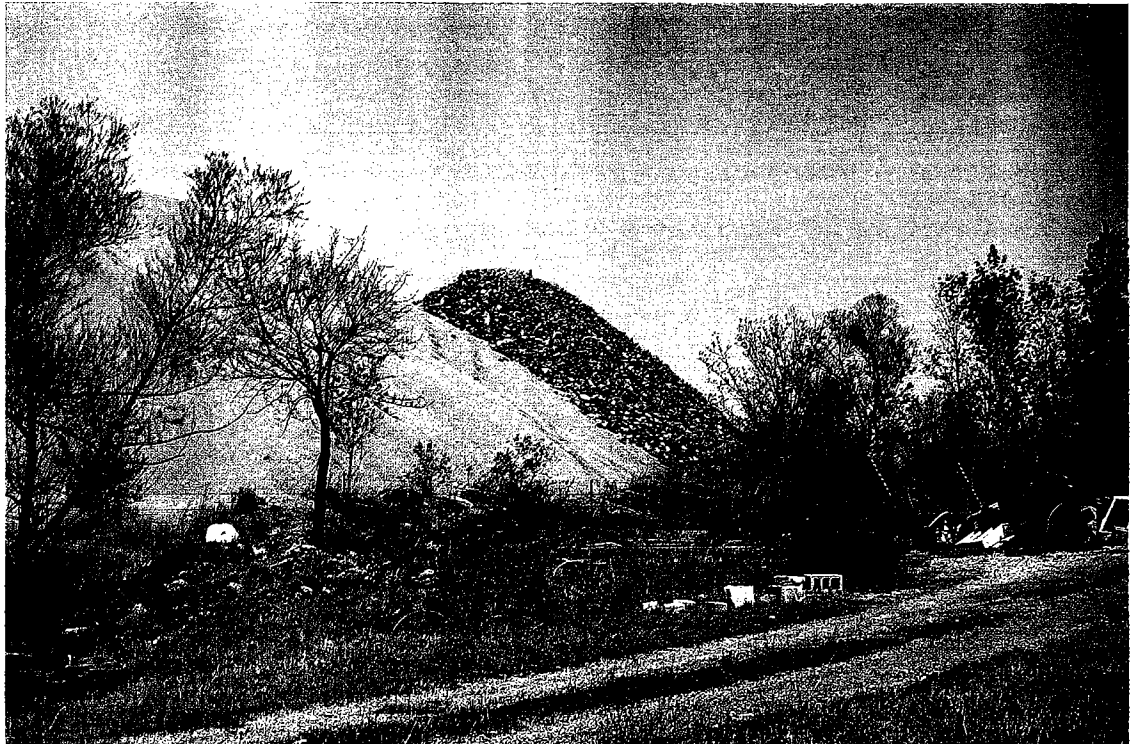
Figure 9. Large chat pile (*left*) and boulder (*right*) at Howe Mine (29N-23E-17).

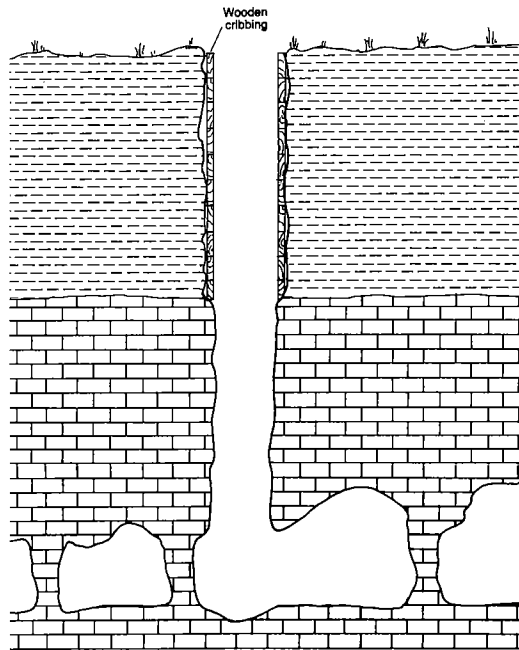
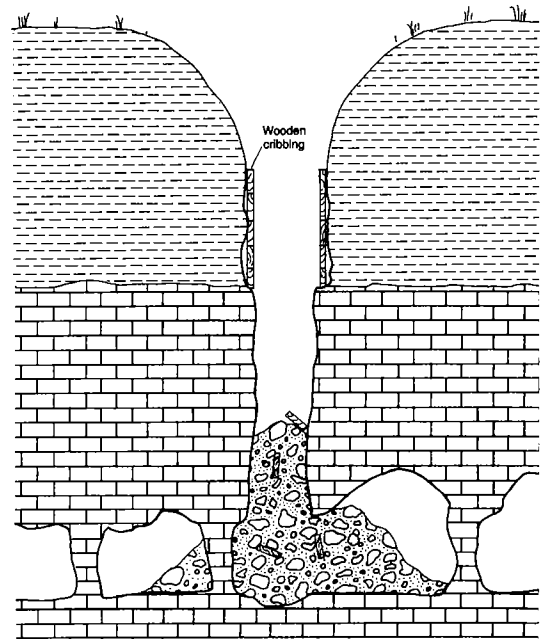
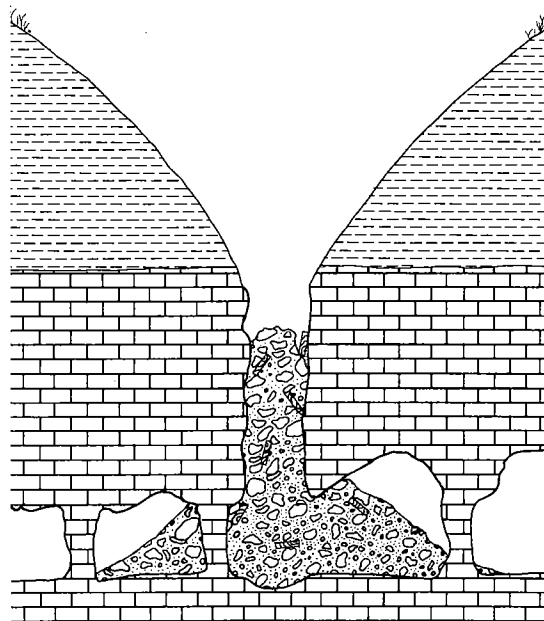
Most surface-collapse sites in the Oklahoma portion of the Picher Field are associated with abandoned mine shafts. Many shaft collapses begin with the deterioration of the wooden cribbing near the shaft collar (Fig. 10). Generally, a 40- to 60-ft-thick sequence of interbedded shale and sandstone occurs near the surface. This material is highly susceptible to erosion and will cave in toward the shaft. Many of the cave-ins are 20–60 ft in diameter (Fig. 11). Cave-ins that extend into the underground workings are generally accompanied by spectacular surface collapses 200–400 ft in diameter (Figs. 12,13). There are 481 shafts either open or in some stage of collapse. Probably 316 of these shafts could be closed or sealed.

Figure 10. Sequence of schematic cross sections illustrating various stages of surface collapse associated with shaft failure. A, typical open shaft and underground mine workings. B, early stage of shaft failure. C, advanced stage of shaft failure.

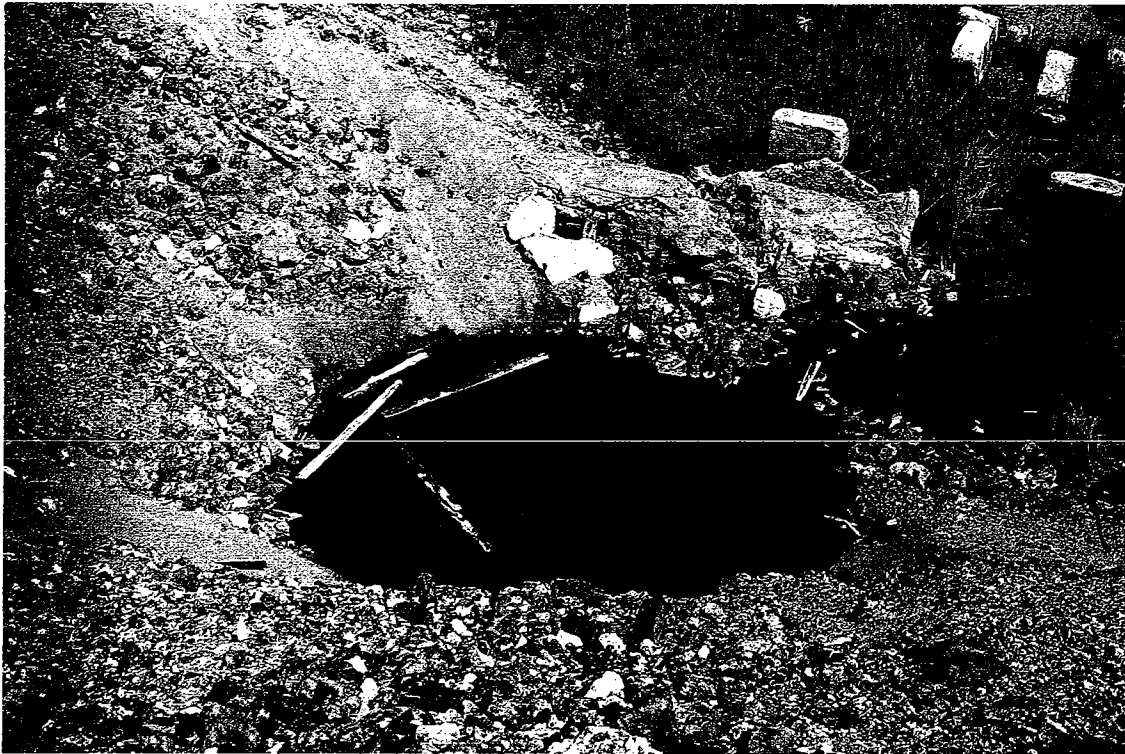
Figure 11. A 20-ft-diameter circular collapse, Howe Mine, 29N-23E-17(41).

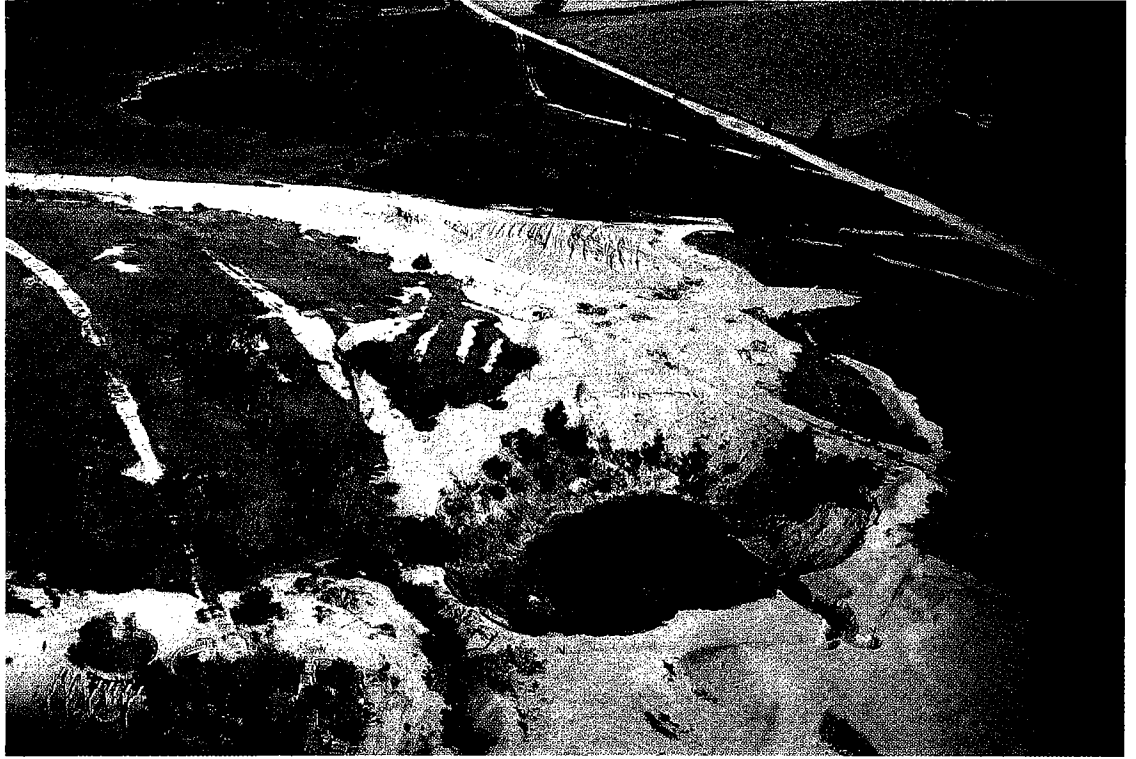
Figure 13. Two major shaft-related collapses, Anna Beaver lease, 29N-23E-19 (6, upper; 7, lower).

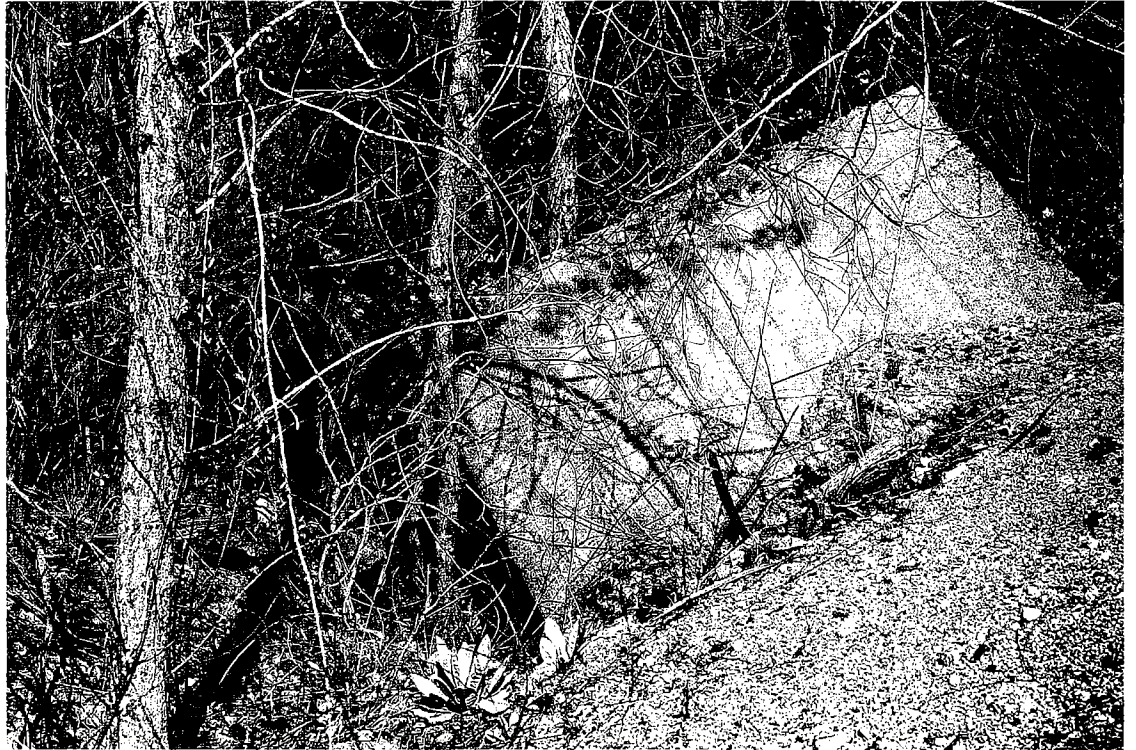
Figure 14. A 6.5-ft concrete cube used to seal a shaft on Grace Walker lease, 29N-23E-21(41).

when moderate-sized collapse features were associated with some shafts. A 6.5-ft concrete cube was fabricated at the site (Fig. 14). After the concrete was completely hardened—generally being allowed to set for at least a week—light charges of dynamite were used to blow out support for the cube on the side nearest the shaft, thereby allowing it to topple into the shaft opening. This method of sealing a caved shaft was found to be highly satisfactory, even though no control could be exerted over the final position of the cube. Some of the existing caved shafts in the Picher Field could be sealed in this manner.

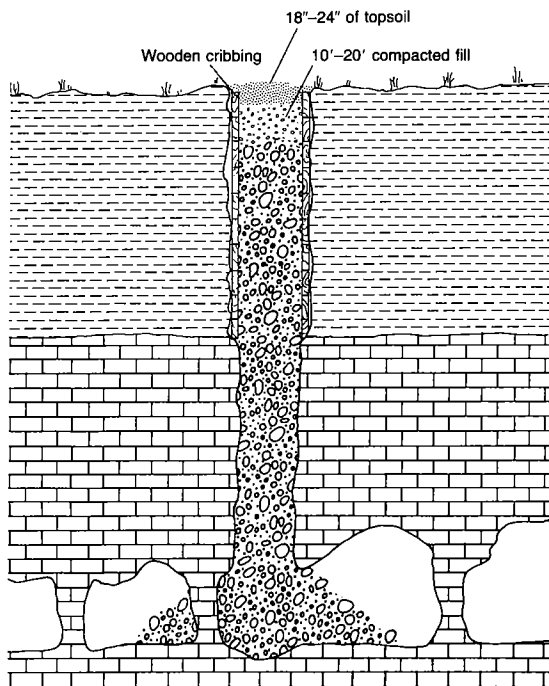
Figure 15. Schematic cross section of open mine shaft, illustrating one way to seal or close the opening in early stage of shaft failure.

An open mine shaft like the one depicted in Figure 10A may be filled in the manner shown in Figure 15. Material dumped into a mine shaft will generally form a conical pile on the floor of the underground mine working below the shaft. The size of the pile will depend on the type of material used, the height of the pile (vertical distance between the floor and ceiling), and the proximity to nearby support pillars. The angle of repose, or angle at which loose material will come to rest on a pile, varies with the frictional properties of the material and increases slightly as the size and angularity of the fragments increase.

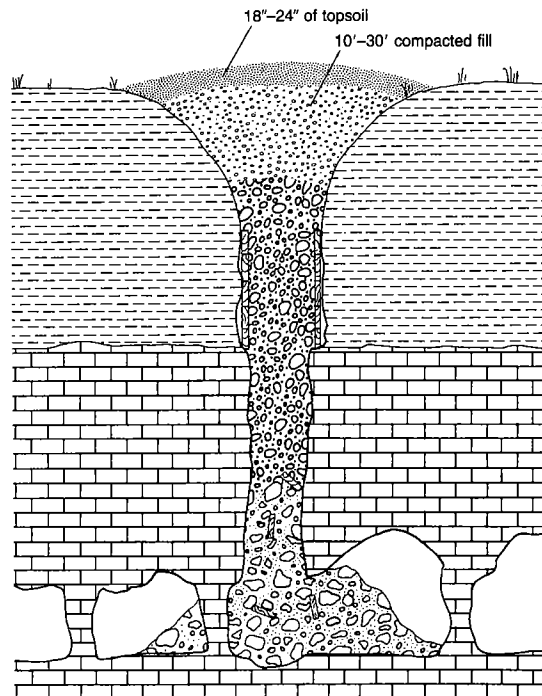
Figure 16. Schematic cross section of shaft site illustrating one way to seal or close the site in early stage of shaft failure.

An example of one way to fill a site that is in an early stage of shaft failure is illustrated in Figure 16. The shaft-filling technique is almost the same as that for an open shaft. Debris derived from material that caved into the shaft is shown occupying the lower part of the mine shaft. Most commonly, the underground opening is sufficiently large that the debris pile resulting from surface collapse is not high enough to extend upward into the shaft. The debris is usually composed of poorly consolidated, saturated shale and sandstone fragments and will offer little support to any fill material dumped on top of it. Therefore, initial volume estimates could assume that the debris plays no role in a shaft-filling program. After several shaft-collapse sites are filled, volume estimates could be modified to reflect actual site conditions.

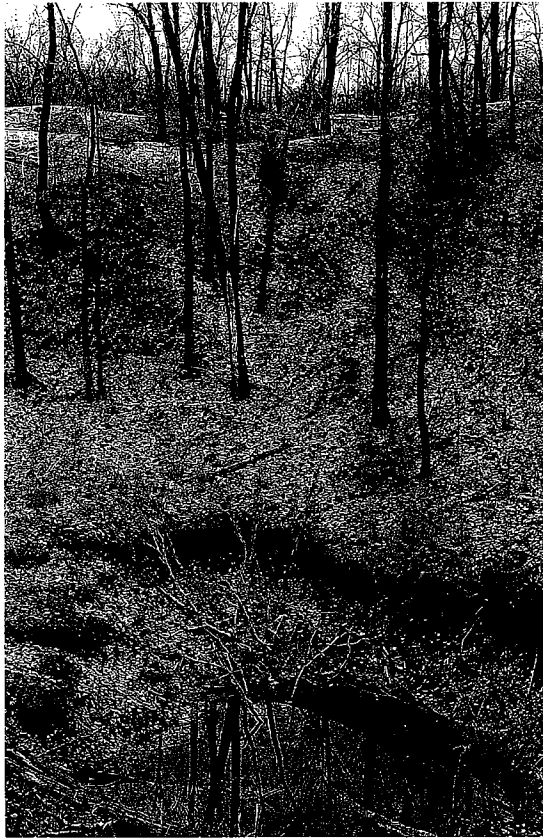
Figure 19. Trees growing in the bottom and sides of a 160-ft circular non-shaft collapse, Crystal Mine, 29N-23E-19(1507).
