LITHOSTRATIGRAPHY OF THE WOODFORD SHALE, ANADARKO BASIN, WEST-CENTRAL OKLAHOMA

**SHALES
MOVING
FORWARD...**

July 21, 2011

Craig D. Caldwell
Cimarex Energy Co.

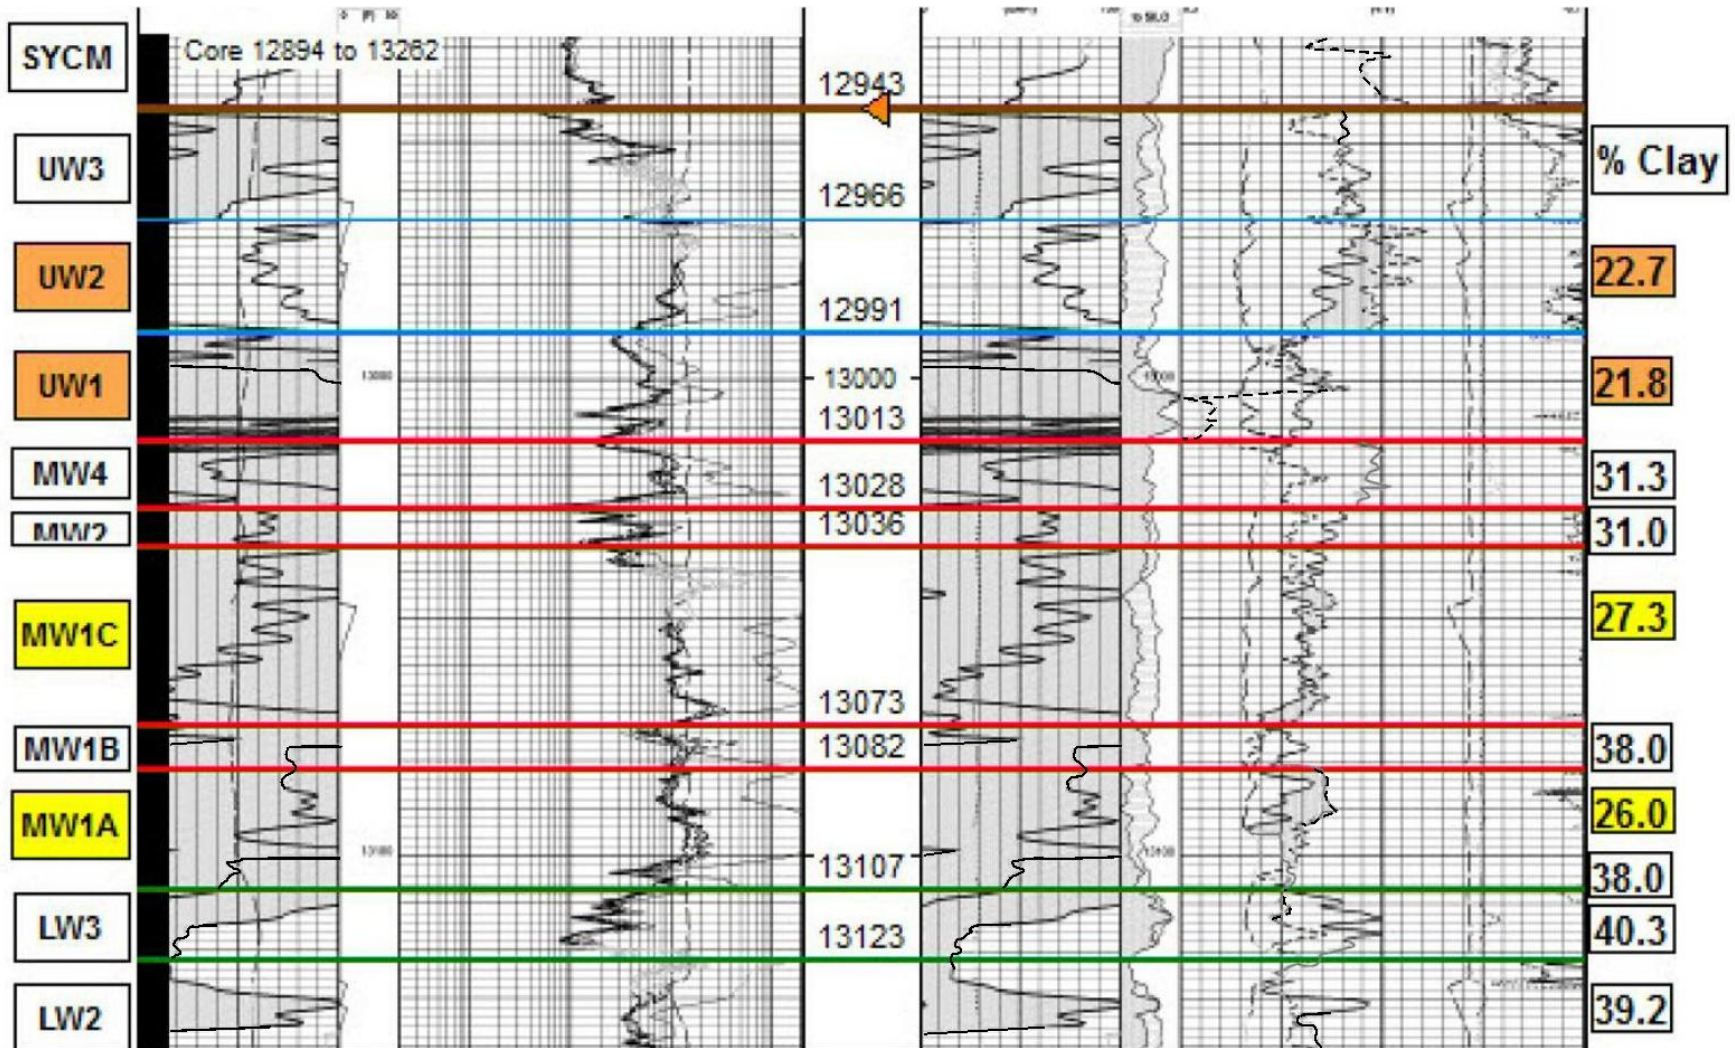
Type Log from Core Area Showing Lithostratigraphy and % Clay for Middle & Upper Woodford

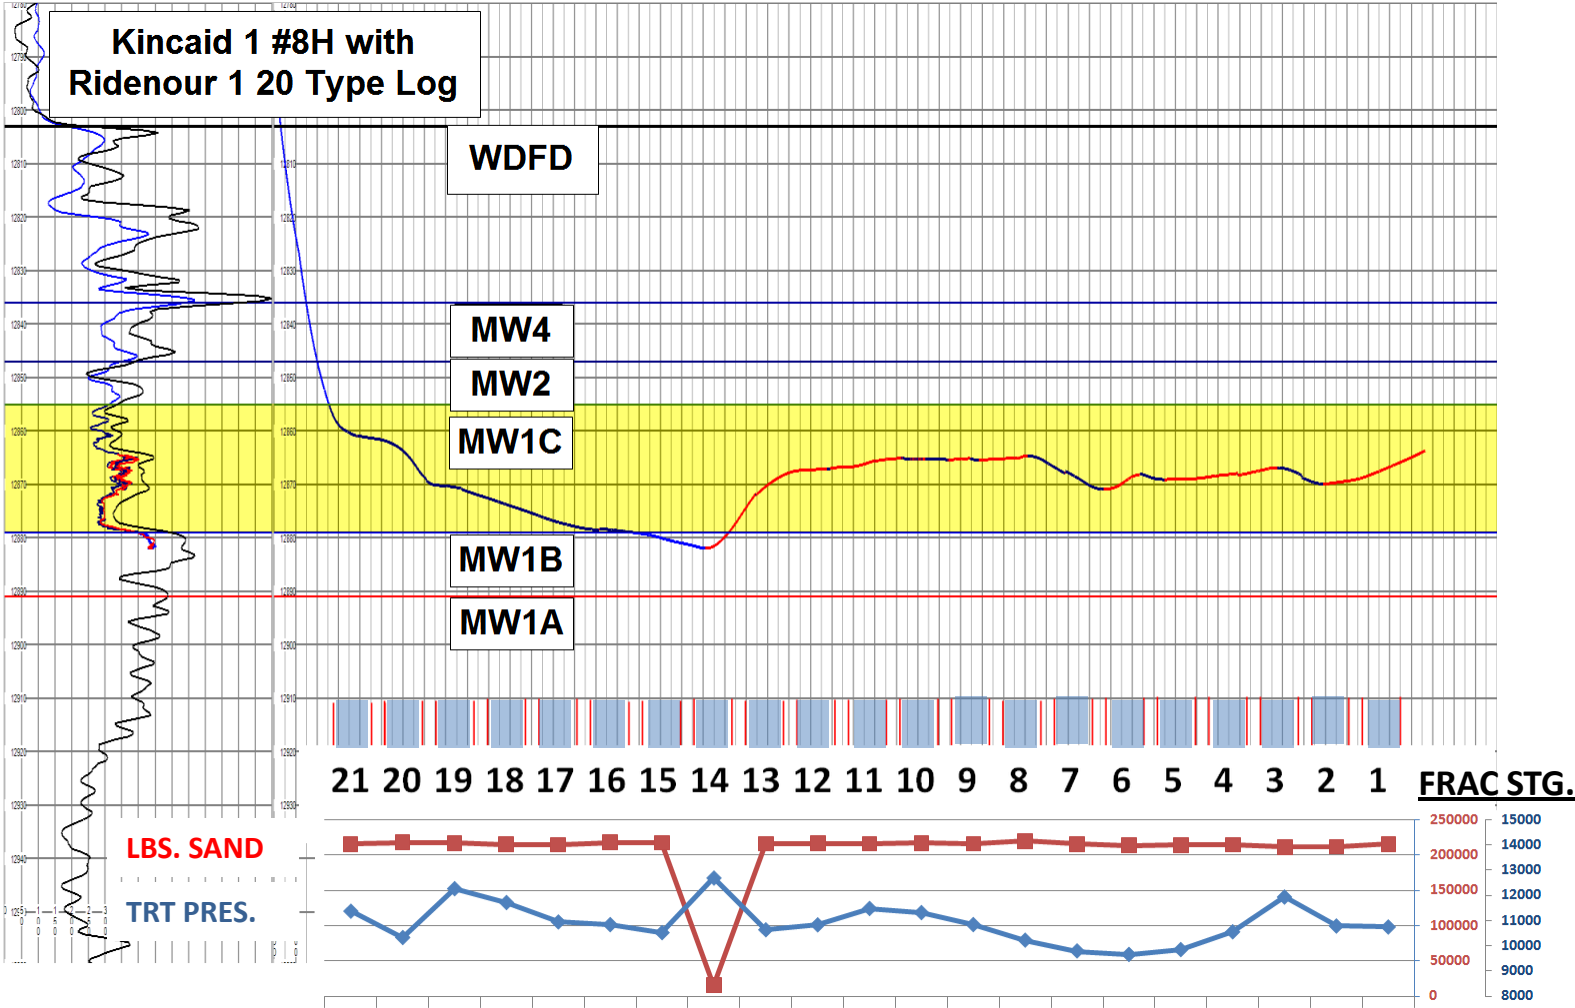
Well Path Showing Woodford Lithostratigraphy and Lateral Placement

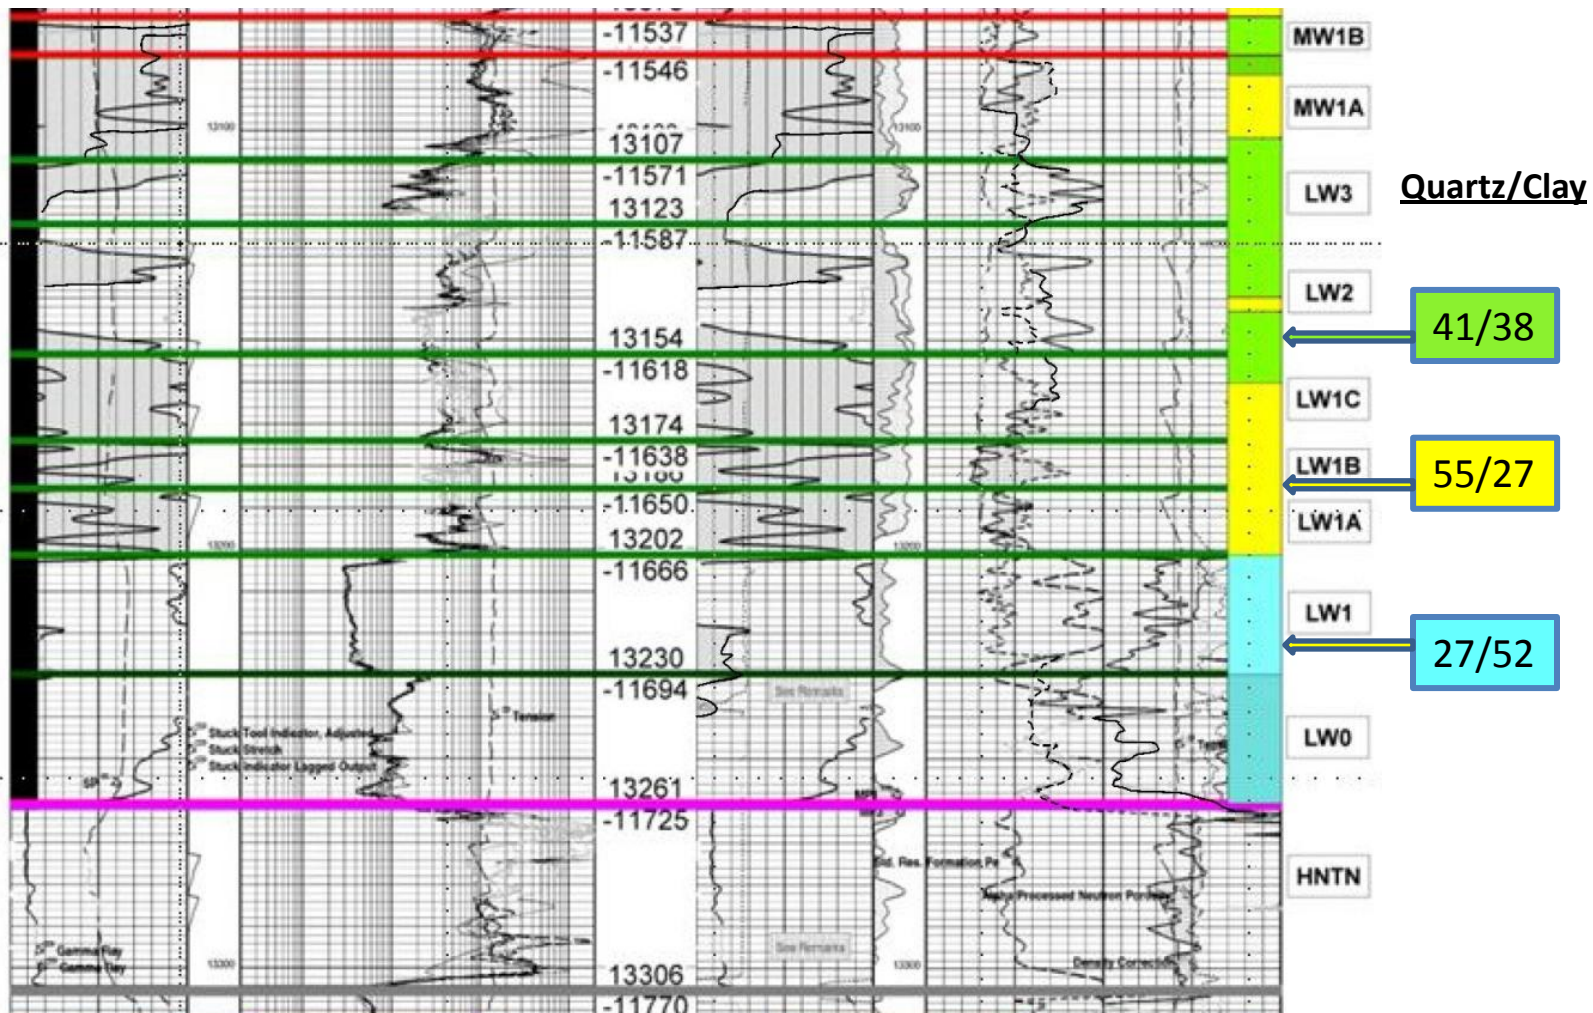
Lower & Middle Woodford Lithostratigraphy, Anadarko Woodford Play – Core Area

Silicic mudstone	Silty, argill mudstone	Organic-poor, argill mudstone	Silty, pry, orgn-rich mudstone
Silty, argill, silicic mudstone	Silty, argill, pyr/dolo mudstone	Organic-poor, silty, argill mudstone

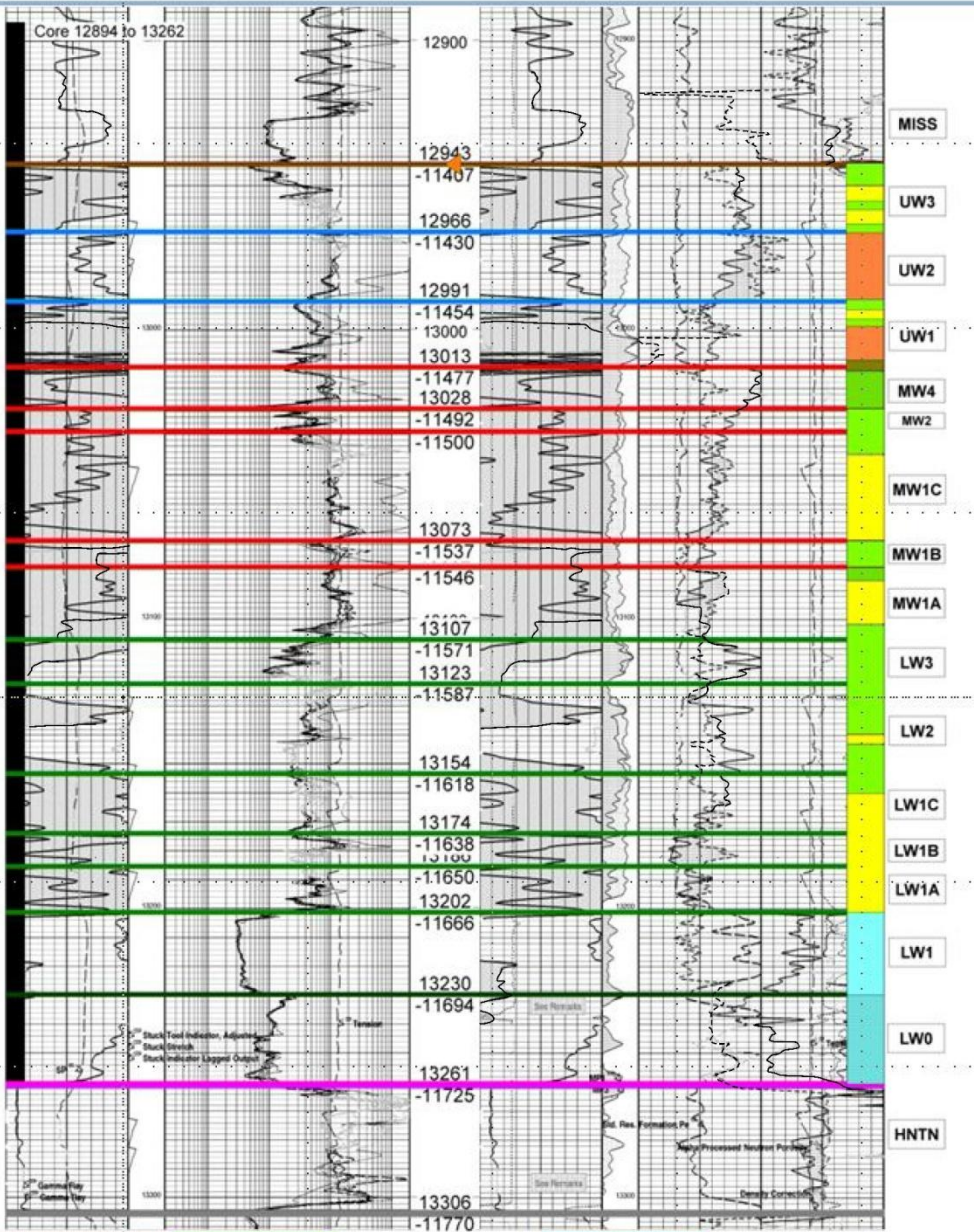
Woodford Lithostratigraphy Anadarko Basin Woodford Play Core Area

Silicic mudstone	Silty, argill mudstone	Organic-poor, argill mudstone	Silty, pry, orgn-rich mudstone
Silty, argill, silicic mudstone	Silty, argill, pyritic mudstone	Organic-poor, silty, argill mudstone

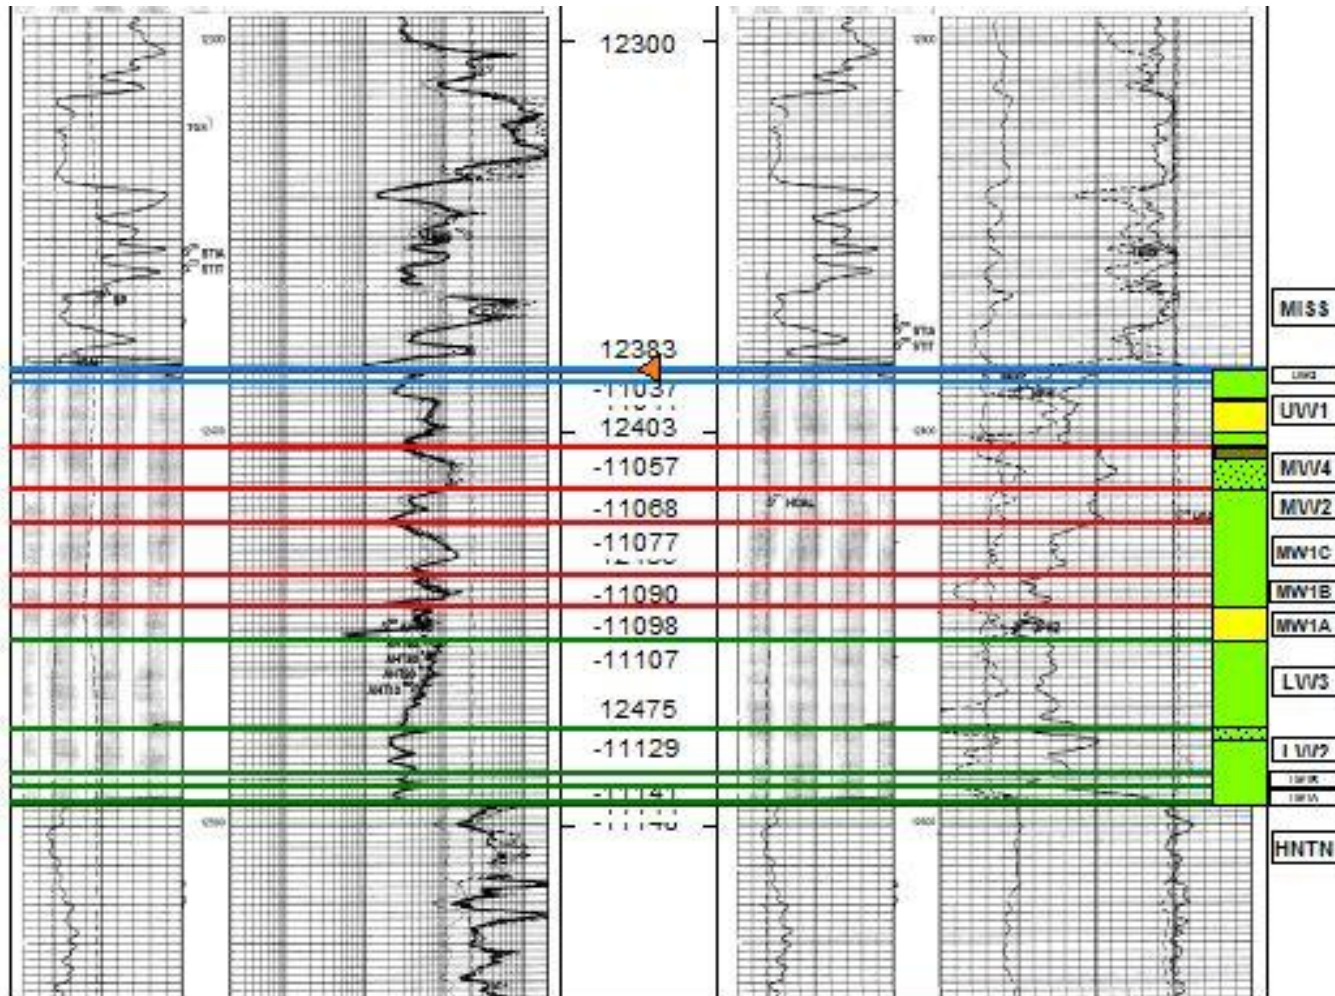
Woodford Lithostratigraphy Anadarko Basin

Woodford Play - SE Area

Silicic mudstone

Argillaceous mudstone

Organic-poor, argill. mudstone

Silty, pry, orgn-rich mudstone

Argillaceous, silicic mudstone

Argillaceous pyritic mudstone

Organic-poor, silty argill. mudstone

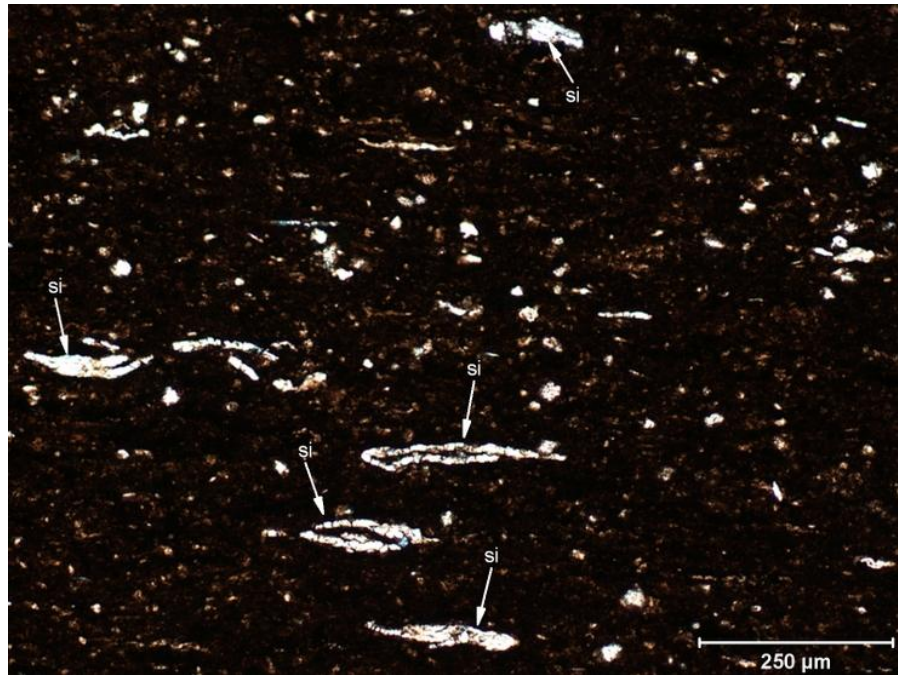
UW1 sample showing silicified Tasmanites; sample is 64% quartz and 21% clay. Silicic mudstone lithofacies.

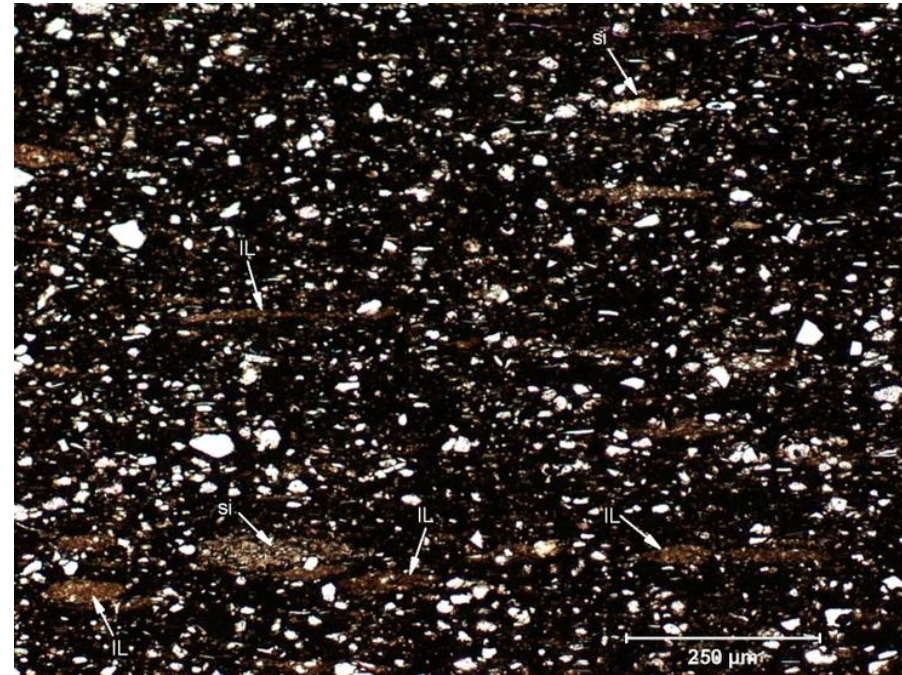
MW1B sample showing detrital silt; sample is 34% quartz and 38% clay. Argillaceous mudstone lithofacies.

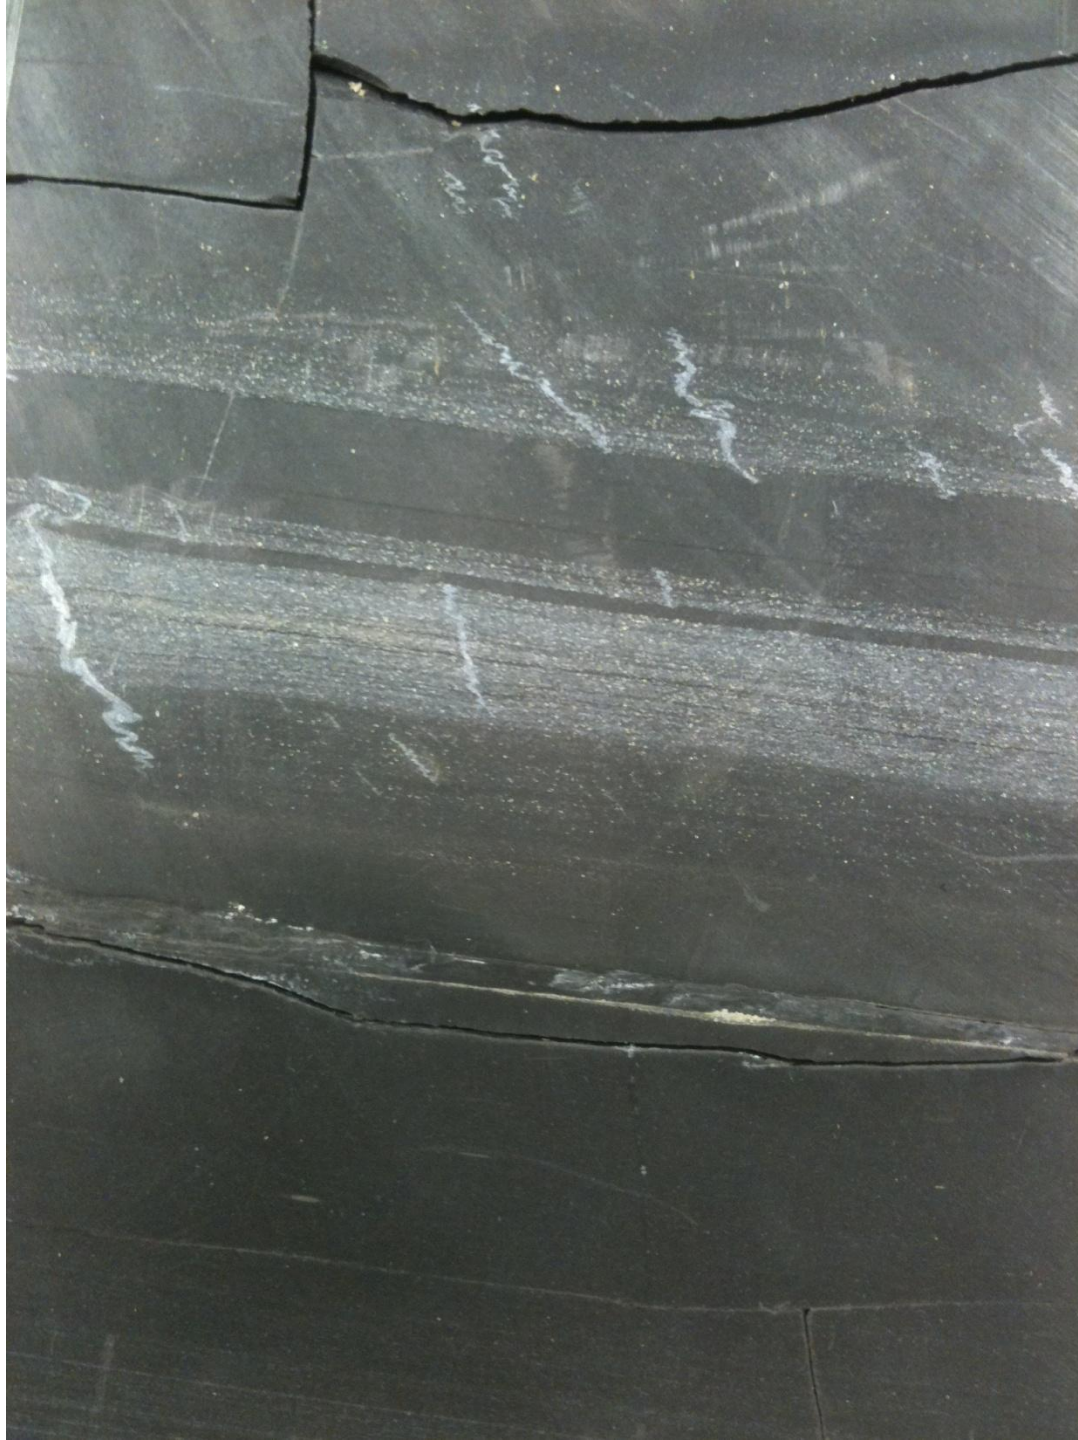
**Bed-limited
dolomite-cemented
fractures in thin
silicic layers**

**Silicic mudstone
lithofacies**

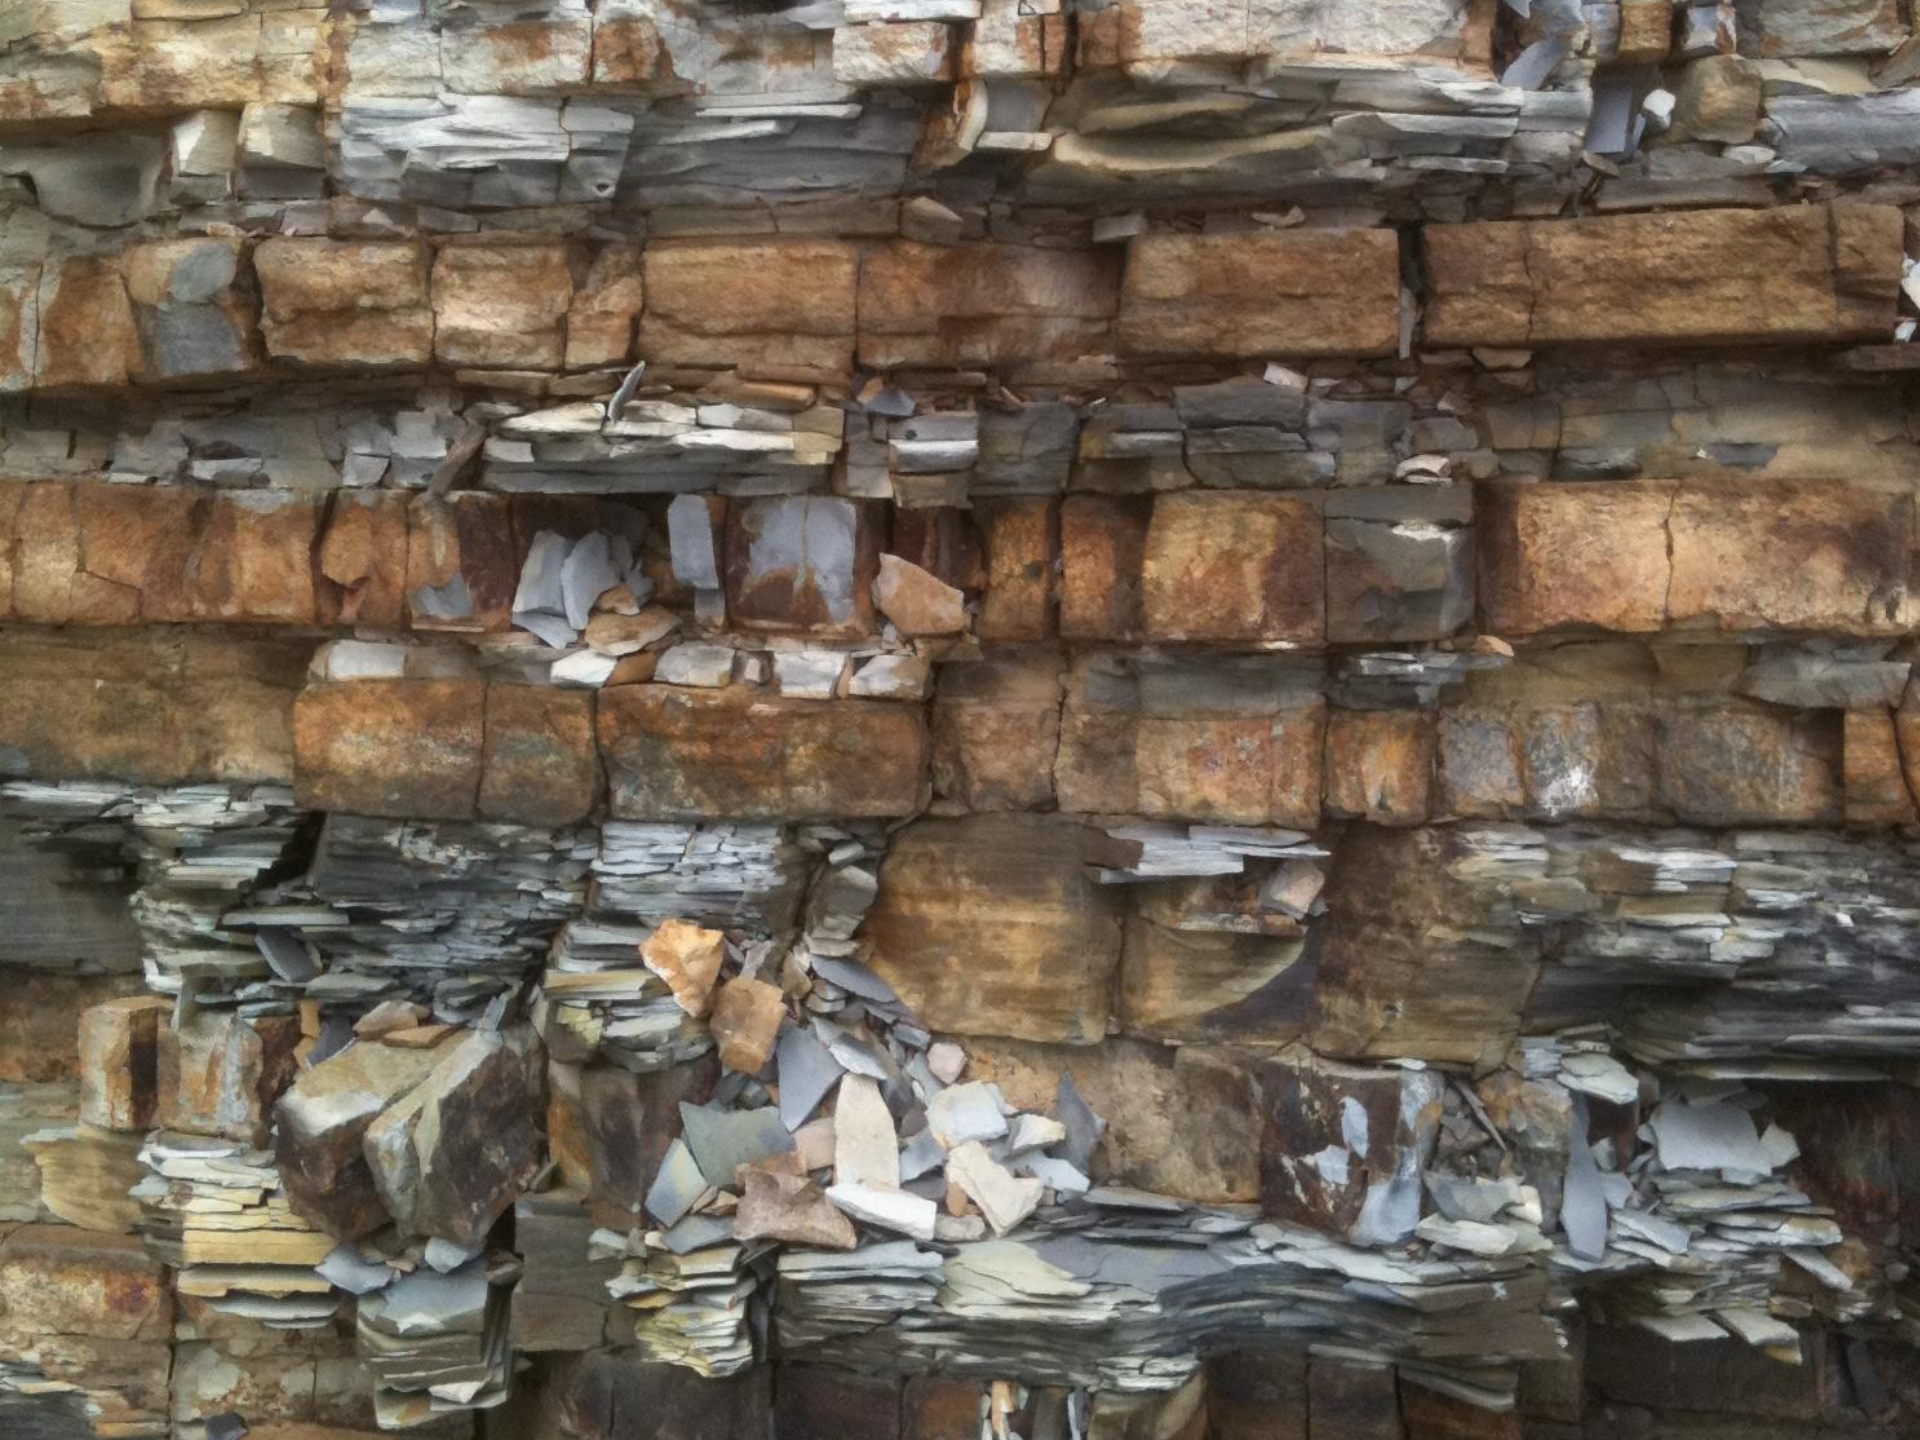
**Thin section scan showing silicic laminae
Argillaceous silicic mudstone lithofacies**

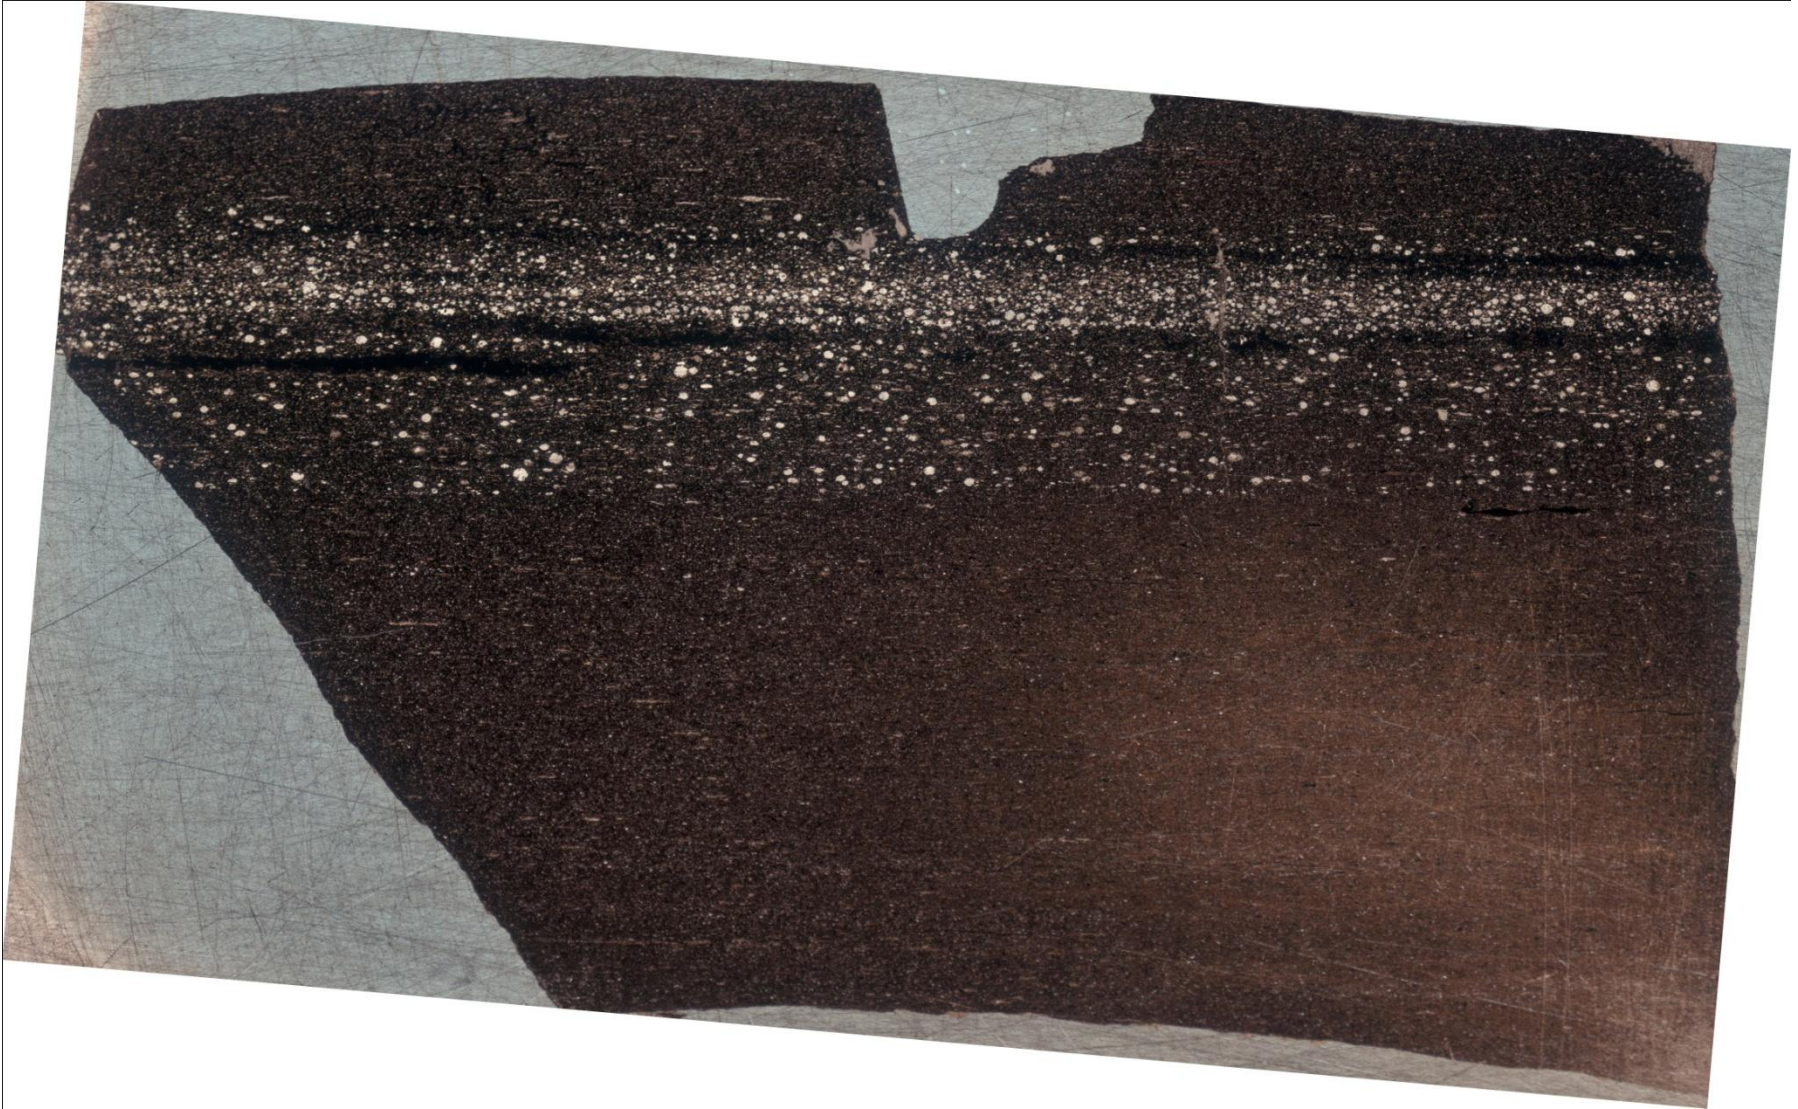
Silicic laminae with dolomite-cemented fracture

Silicic mudstone lithofacies

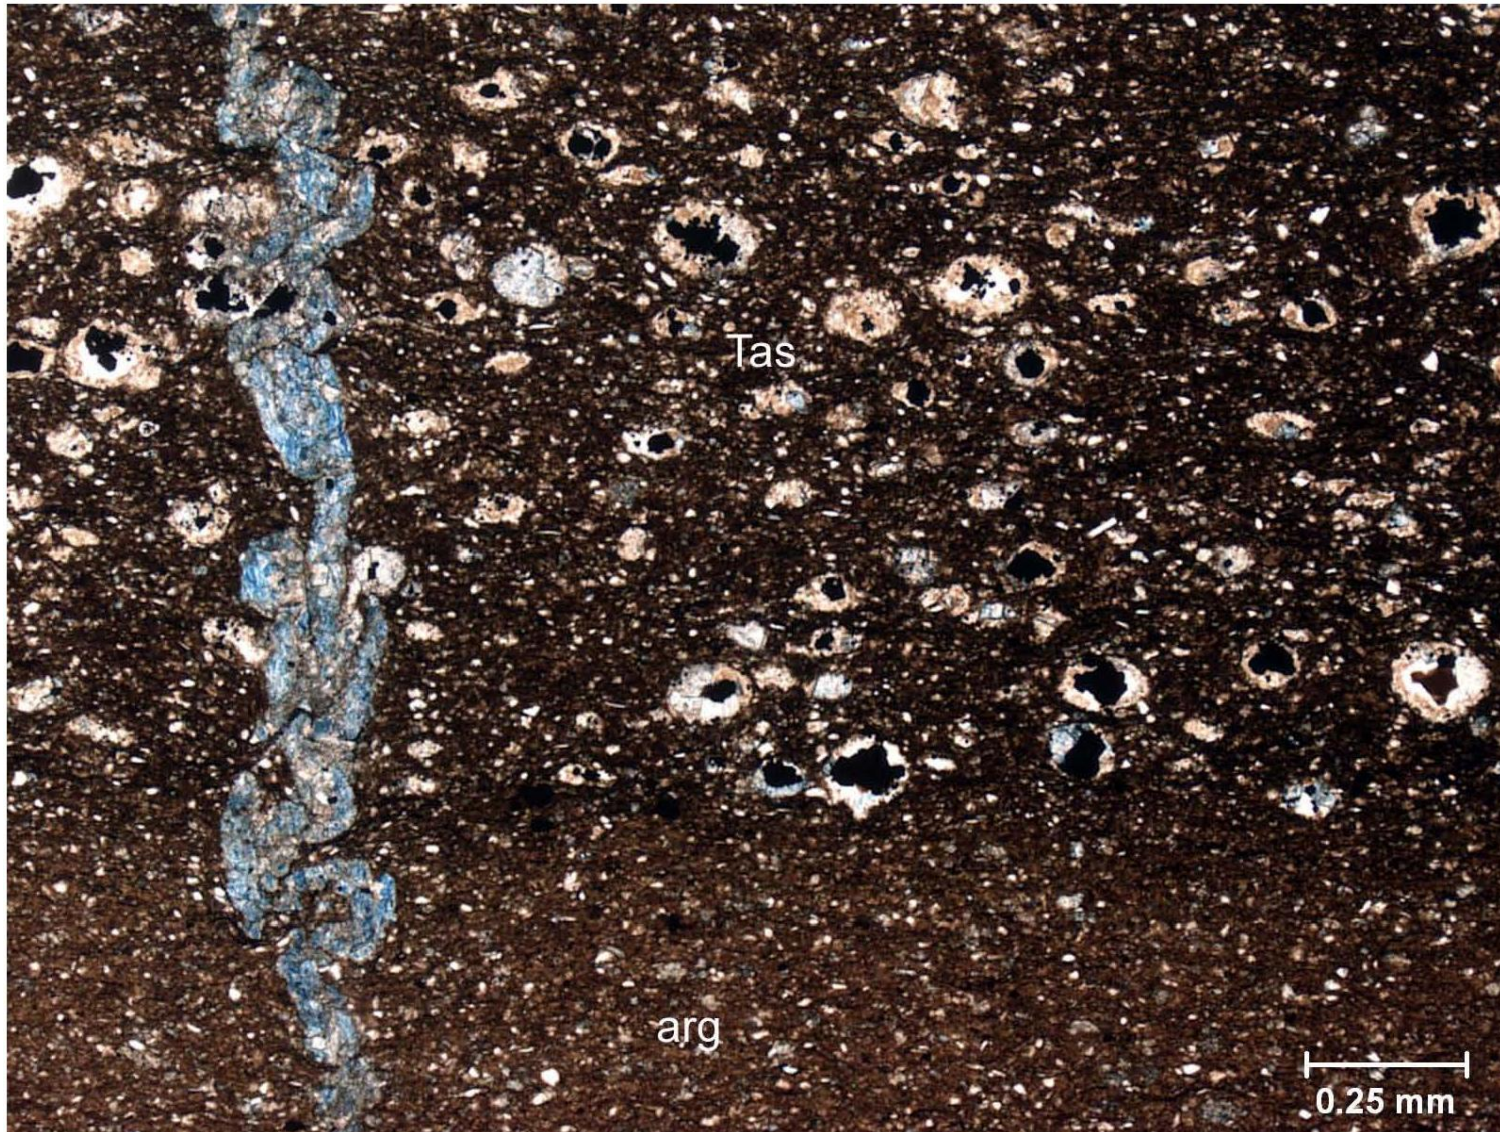
Organic laminations Silicic mudstone lithofacies

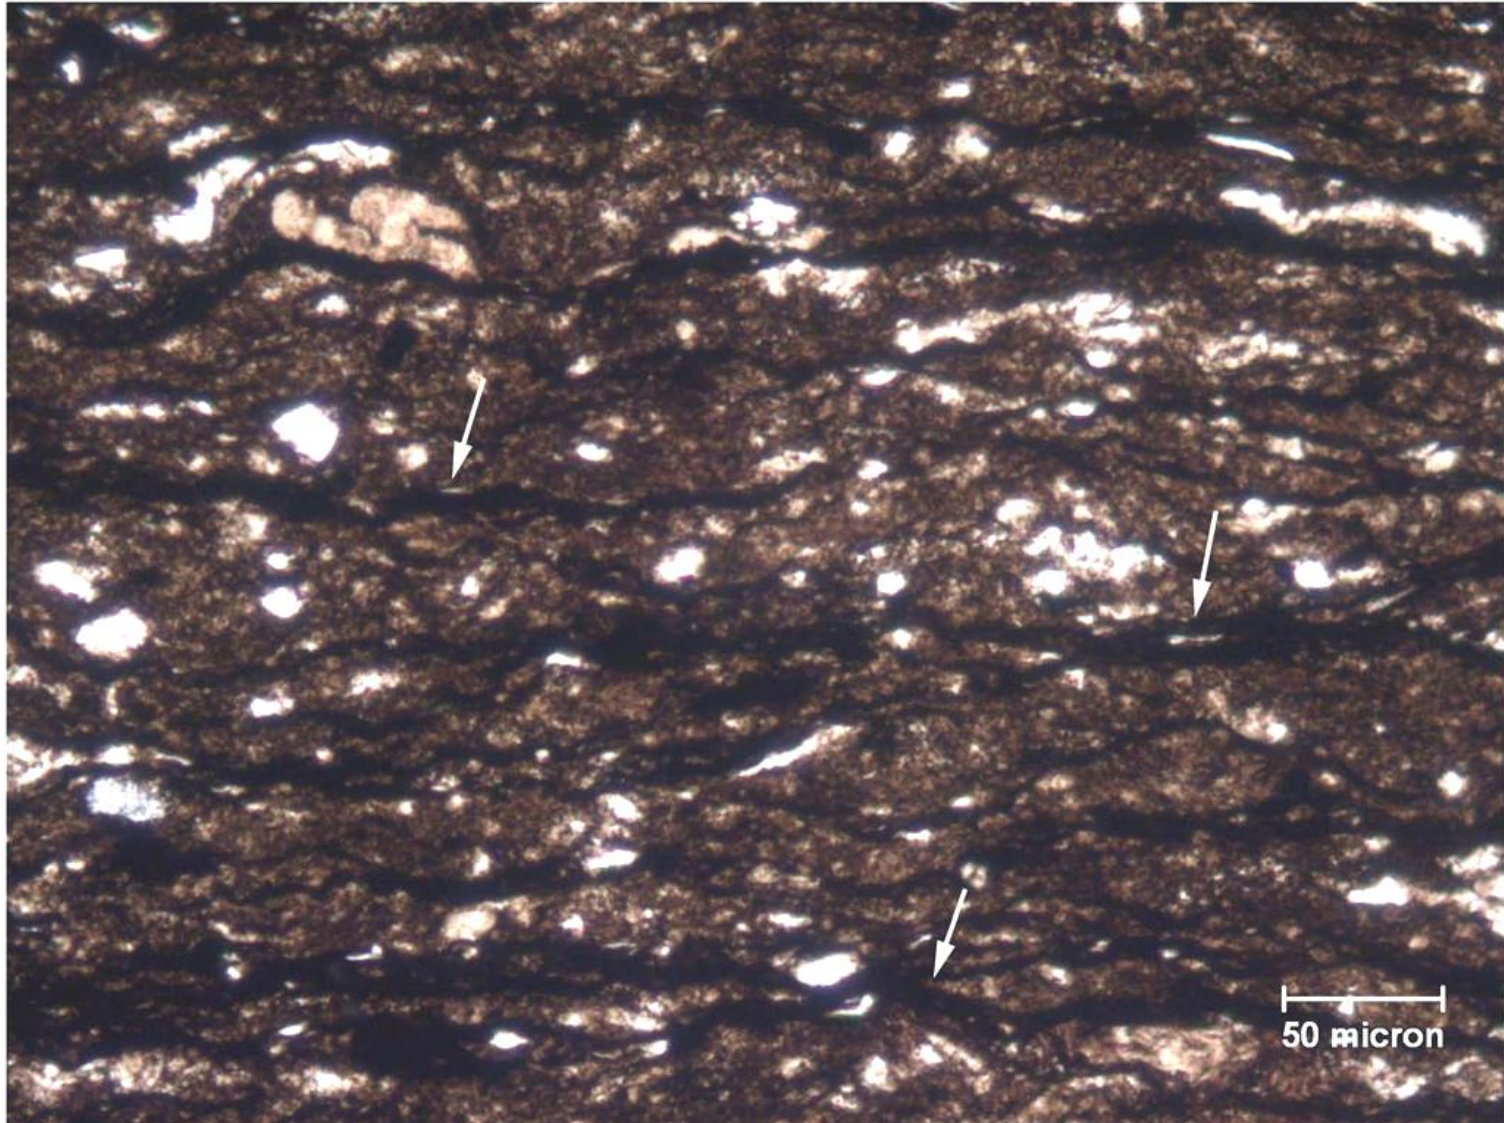
Porosity in organic laminae

Argillaceous silicic mudstone

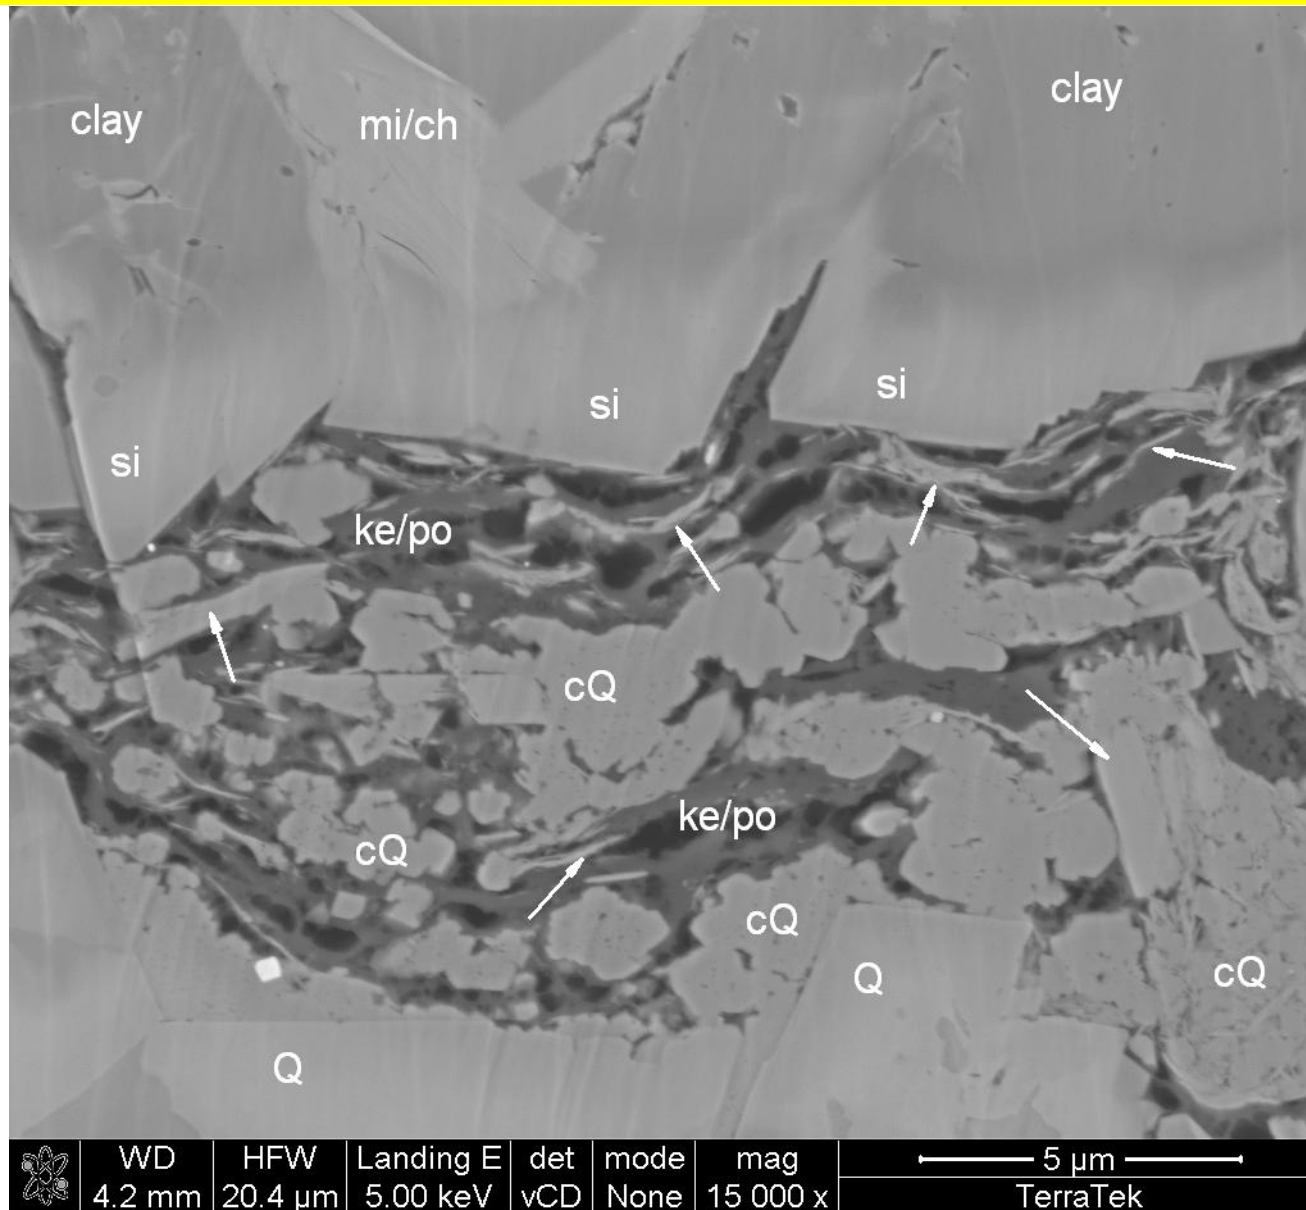
13115

**Bioturbated bed
Argillaceous
mudstone lithofacies**

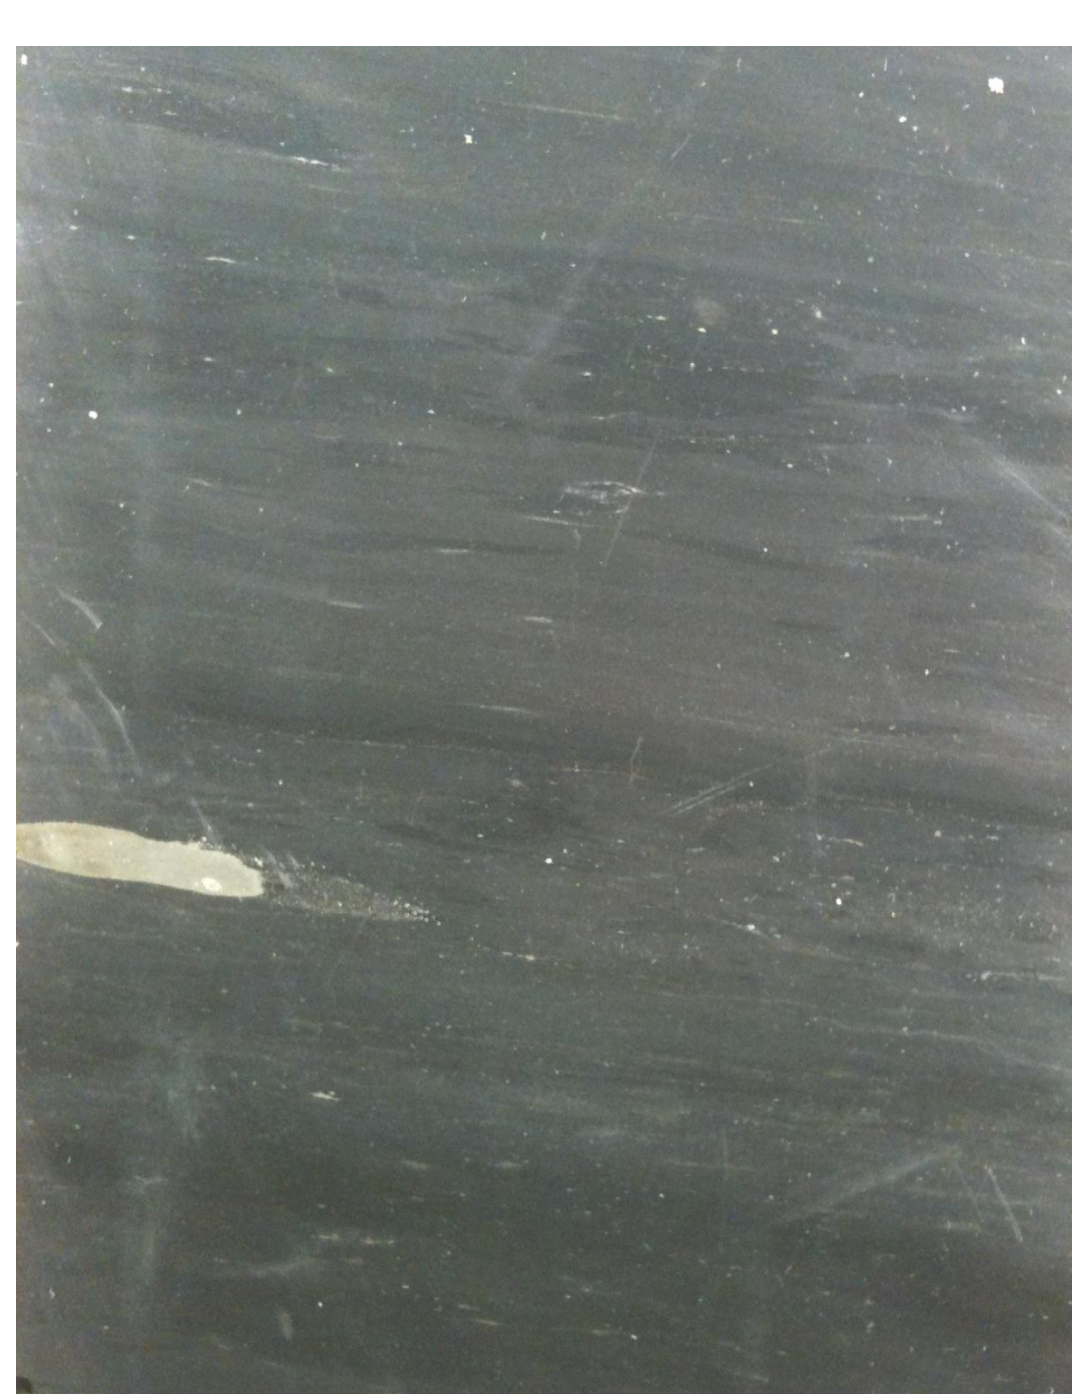
A photograph showing a dark, almost black, sedimentary rock surface. The surface exhibits fine-scale, wavy, and irregular patterns characteristic of bioturbation. There are some lighter-colored, possibly silicified, features scattered across the surface, including a prominent, elongated, light-colored feature on the left side. The overall texture is rough and uneven.

**Bioturbated,
argillaceous bed
Argillaceous silicic
mudstone lithofacies**

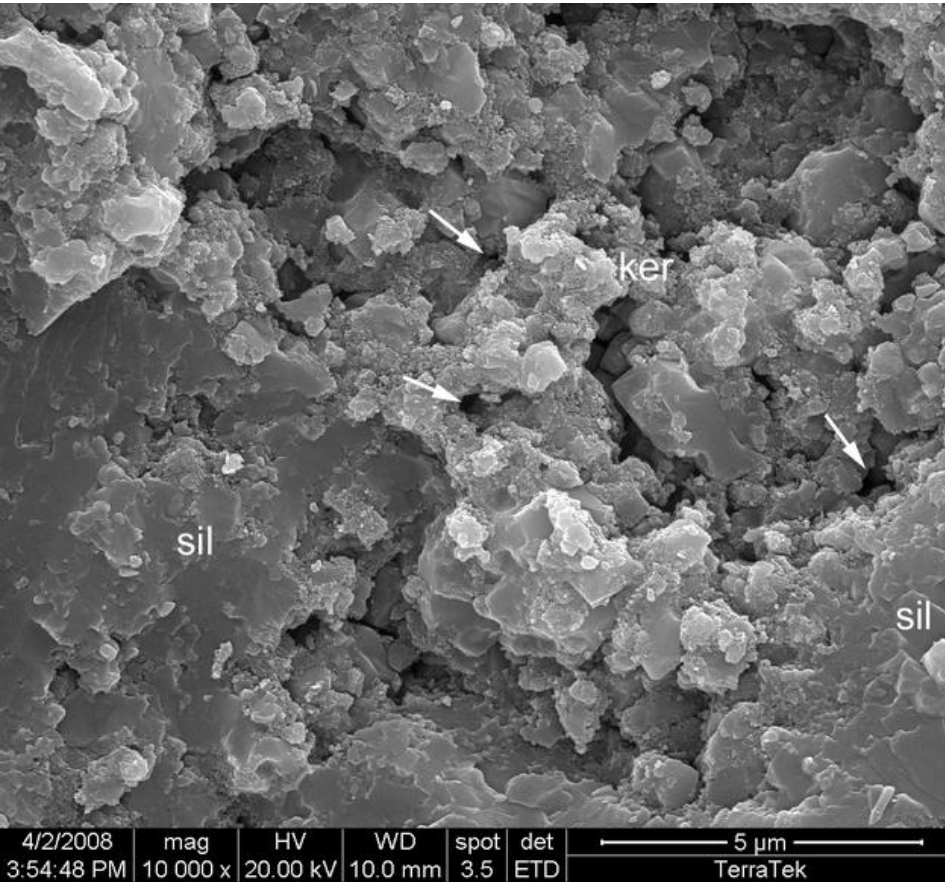
UW2 sample showing microcrystalline silica with intercrystalline porosity; sample is 76% quartz and 18% clay. Silicic mudstone lithofacies.
