LITHOSTRATIGRAPHY OF THE WOODFORD SHALE, ANADARKO BASIN, WEST-CENTRAL OKLAHOMA

**SHALES
MOVING
FORWARD...**

July 21, 2011

Craig D. Caldwell
Cimarex Energy Co.

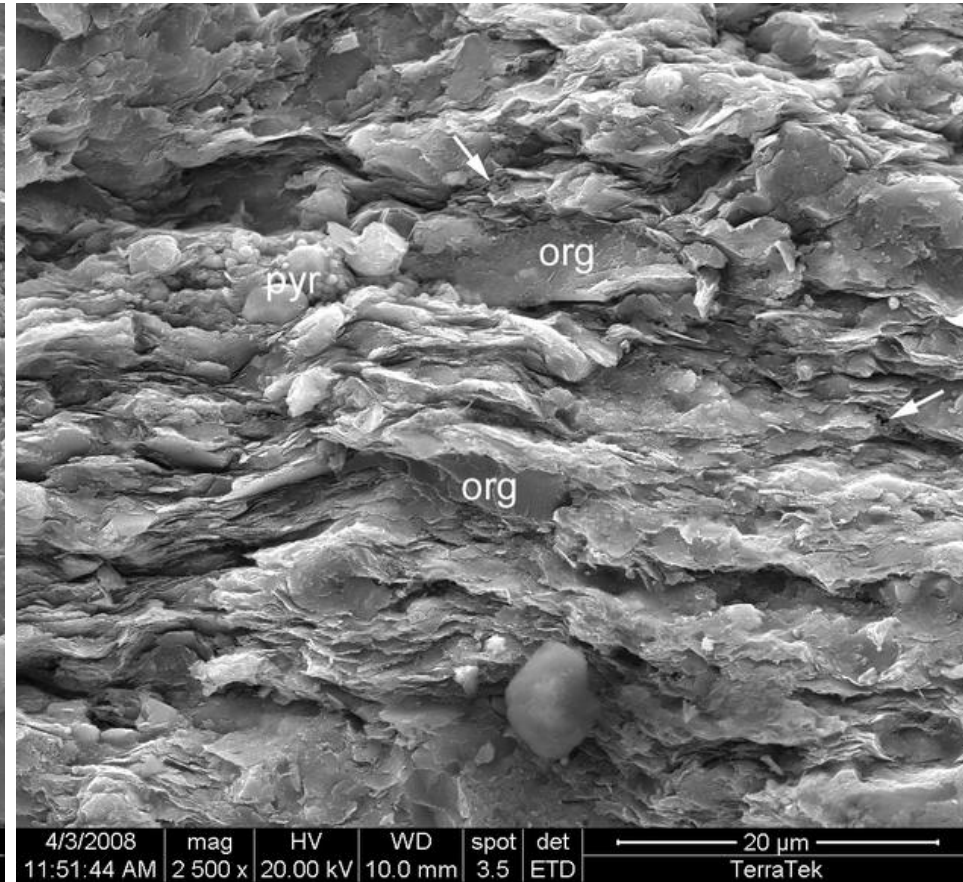
MW4 sample showing parallel alignment of illite clay; sample is 26% quartz and 44% clay. Argillaceous mudstone lithofacies.
